Evaluation of Metal Core Arc Welding for Bridge Fabrication

Alberta Transportation and Infrastructure

December, 2006

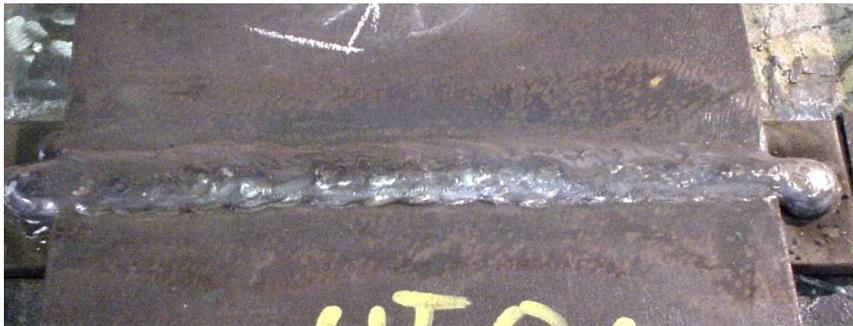
Figure 1 – MCAW butt weld (with backing) with excessive weld height

The visual inspection results for each weld configuration and process are summarized in Table III. Nine (9) SMAW butt welds (with and without backing) failed due poor weld profile. One (1) MCAW butt weld without backing and three (3) MCAW butt welds (with backing) also failed visual inspection due to an excessive height of weld profile (see Figure 1 below). All the fillet and lap welds using the MCAW processes passed visual inspection. Four (4) SMAW lap welds failed visual inspection.

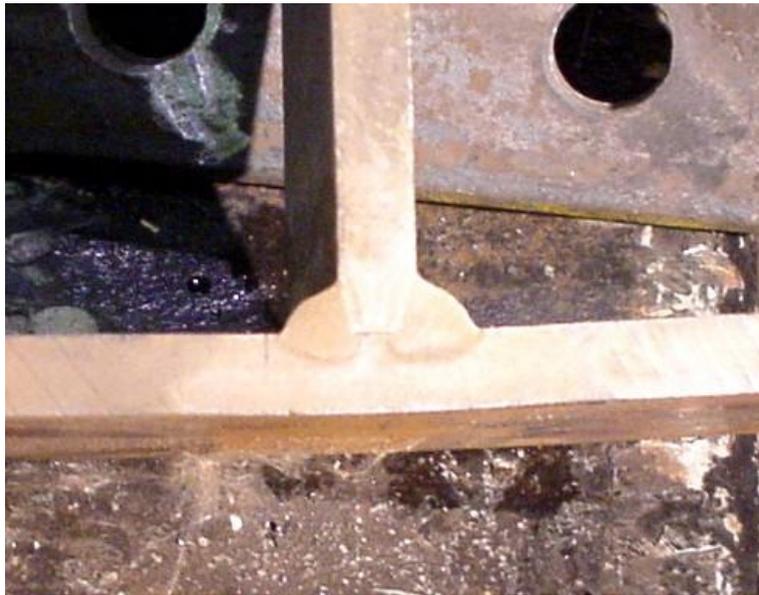
Acid etching was conducted on 36 MCAW welds (21 Fillet and 15 Lap) and on 33 SMAW welds (21 Fillet and 12 Lap). Figures 2 and 3 show the typical penetration profiles for the MCAW and SMAW processes respectively. In general, the MCAW process resulted in greater penetrating weld profiles than SMAW.

Figure 2 – Photo of macro etch for MCAW weld.

Qualitatively, the MCAW welds (for both fillet and lap configurations) were observed to exhibit greater weld penetration depth. This is attributed to the higher current densities that can be applied with a metal core process. Equivalent current densities with SMAW may result in break down of the flux covering and subsequent defects in the weld. The greater weld penetration associated with MCAW can translated into higher quality welds.

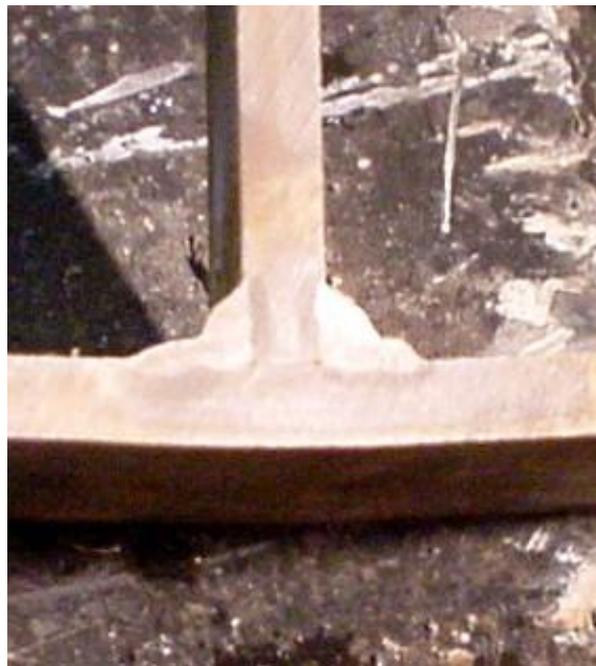
Figure 3 – Photo of macro etch for SMAW weld.
